FIRST ANNUAL REPORT

SYNTHESIS AND EVALUATION
OF
POLYMERIC MATERIALS

GC-TR-92-2303

Prepared for
Naval Research Laboratory
4555 Overlook Avenue, SW
Washington, D.C. 20375-5000

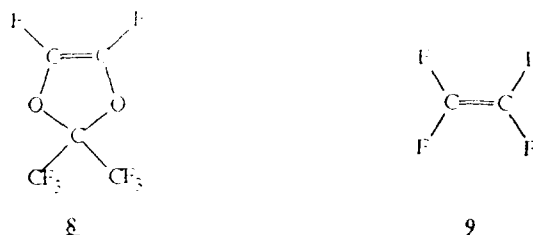
Scheme II

In 1990 Resnick⁷ reported that the lowest dielectric constant (1.89-1.93) of any polymer thus far was obtained from copolymers of 2,2-bis(trifluoromethyl)-4,5-difluoro-1,3-dioxole 8 and tetrafluoroethylene 9 with structures shown in Scheme II. In addition to the effect of the fluorine content, the existence of similar perfluoroalkyl ether linkage on the double bonds in both monomers 8 and 9 seems to play a very important role in further reducing the dielectric constant values.

close to the known minimum dielectric constants of 2.0-2.08 for poly(tetrafluoroethylene) and 1.89-1.93 for a terpolymer of 2,2-bis-(trifluoromethyl)-4,5-difluoro-1,3-dioxole 8, perfluoropropylene and tetrafluoroethylene 9. The dielectric constants for poly(tetrafluoroethylene) measured with the same method are observed to be around 1.96-1.99 in order to validate the accuracy of our measurement.
